CAMP CURRENT PROJECT REPORT

CITY OF TORONTO - PF&R - Capital Projects Section

MacGregor Park Playground

Fieldhouse/Washroom

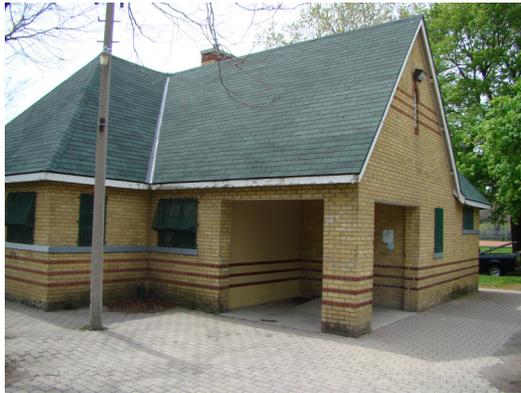
10188_001_AS General front view of the facility.

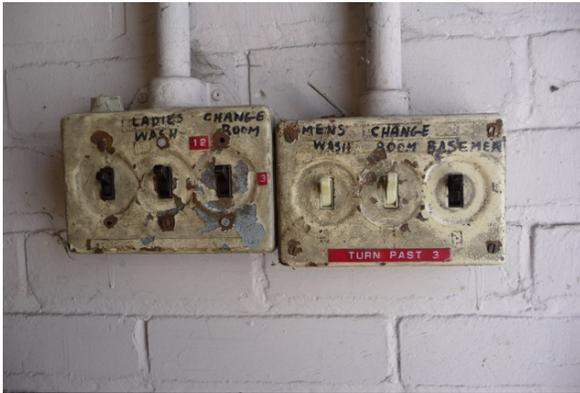
10188_002_ME Access into the basement was prohibited due to reported asbestos hazards.
